RISK MANAGEMENT OF KOPRIVLEN LANDSLIDES

Abstract: The present paper provides detailed results from the implementation of project RISKLIDES in the framework of European Territorial Cooperation Programme “Greece-Bulgaria 2007-2013”. The study shows the geological and hydrogeological features, as well as the risk mitigation strategy, and risk management of two landslides, developed in Miocene-Pliocene sediments next to Koprivlen village, Gotse Delchev municipality, Blagoevgrad region, SW Bulgaria. A detailed characteristic of the area has been made, including data for the seismic situation, water table, and seasonal rain values. Fieldwork included sample collecting, low-scale geological mapping, and core boring. Laboratory analyses were performed on the collected samples for mineralogical phase identification as well as for rock and soil strength. As a result, detailed low-scale 3D GIS maps of the landslides were produced. A landslide risk management and mitigation strategy is provided for the prevention of the development of Koprivlen landslides.

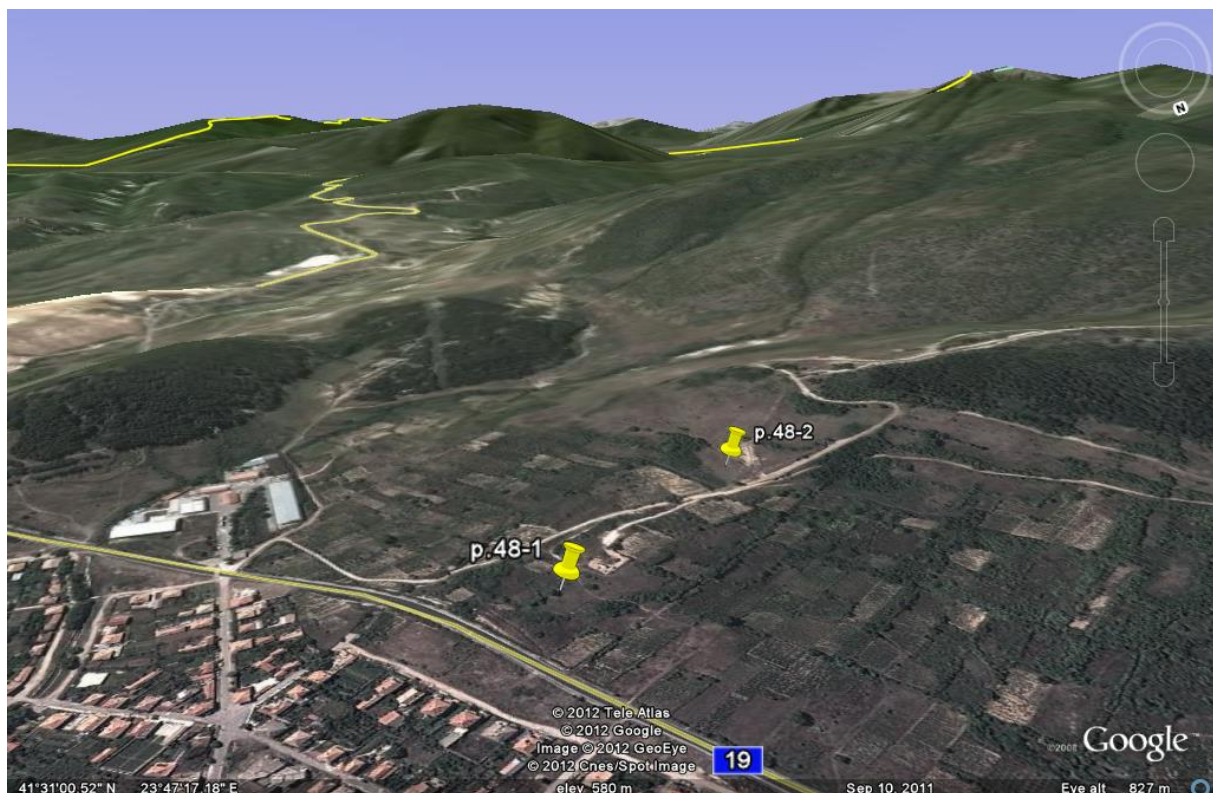
Fig. 2. The two landslides near Koprivlen, Google maps orthophoto

The landslides near Koprivlen are exposed in the southern parts of the village (point 48 – Figure 1). They are a two step-like developed bodies located to the northeast and northwest of benchmark 561.43 m. The central points of both landslides have coordinates as follows: 41 31 12.2/023 47 27.0 (for the northeast body) and 41 37 08.1/23 47 16.1 (for the southwest body), referred later as Koprivlen-1 (p. 48-1) and Koprivlen-2 (p. 48-2) (Figure 2).

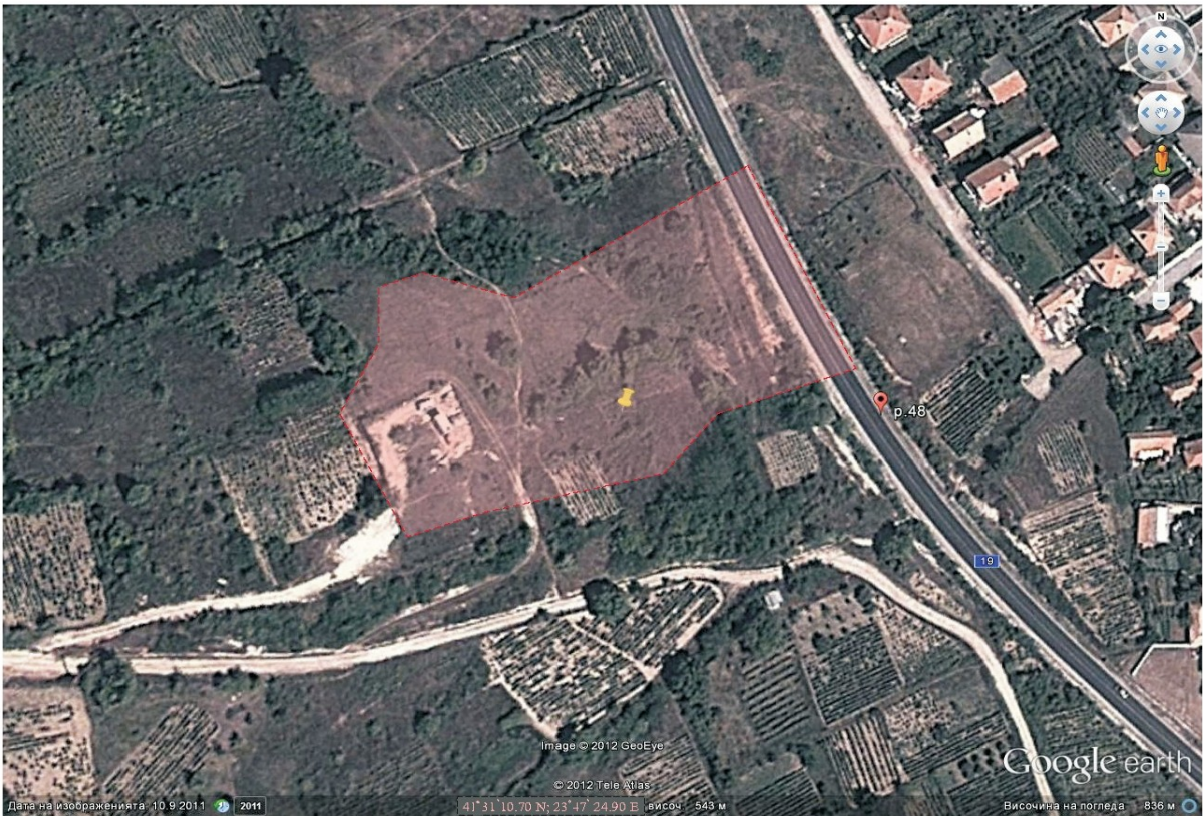
Fig. 3. Area of Koprivlen-1 landslide, superimposed GIS layer over a Google maps orthophoto

Morphostructurally, the landslides at Koprivlen village fall in the southern periphery of the Gotse Delchev basin separated from the Pirin morphostructural Unit by a fault striking at 140°. The lay in the area of the landslide is hilly-plain with altitude ranging from 530-585 m. The landslides are developed in Neogene sediments presented by sandstones, limy siltstones and clays as their slope surface is inclined towards Mesta River. This surface is subjected to sheet and channel erosion, intensively manifested nearby the villages of Sadovo and Novo Lyaski. The areas of the landslides, superimposed over satellite image are shown in Figures 3 and 4.

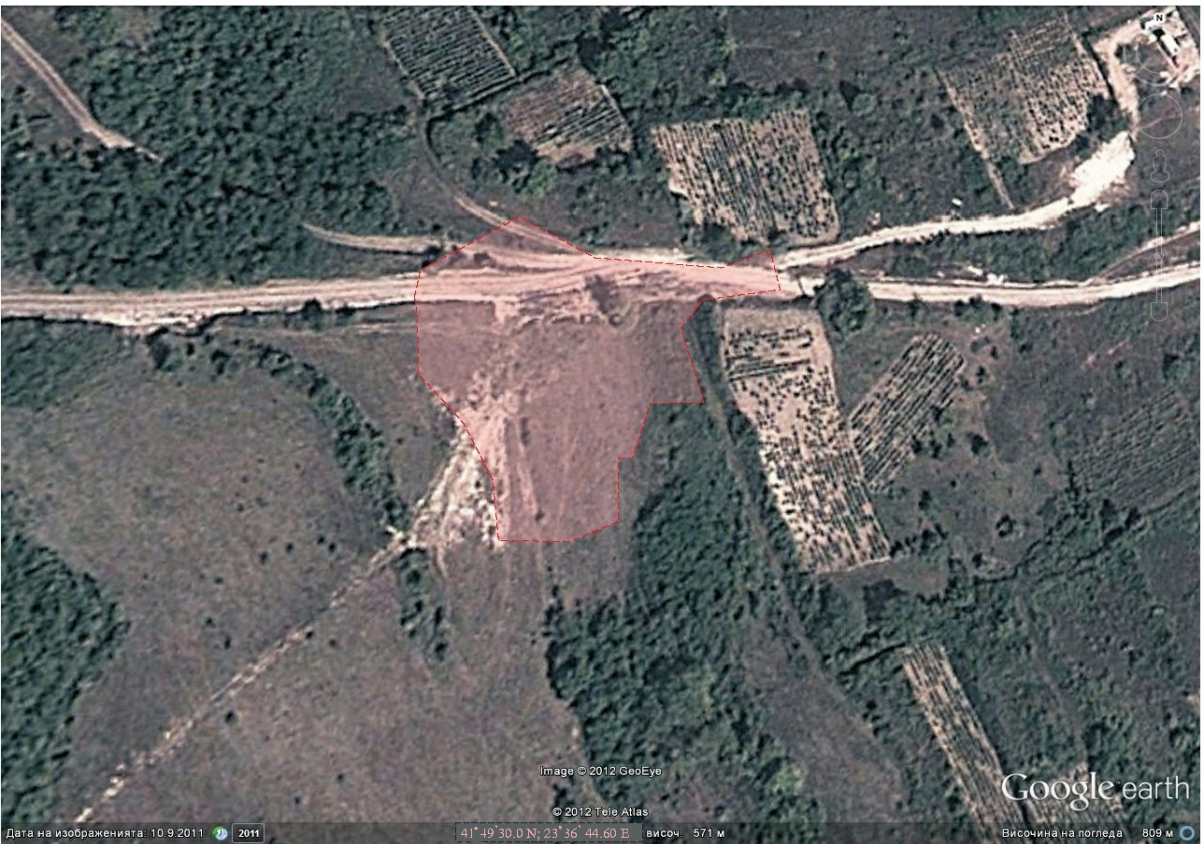
Fig. 4. Area of Koprivlen-2 landslide, superimposed GIS layer over a Google maps orthophoto

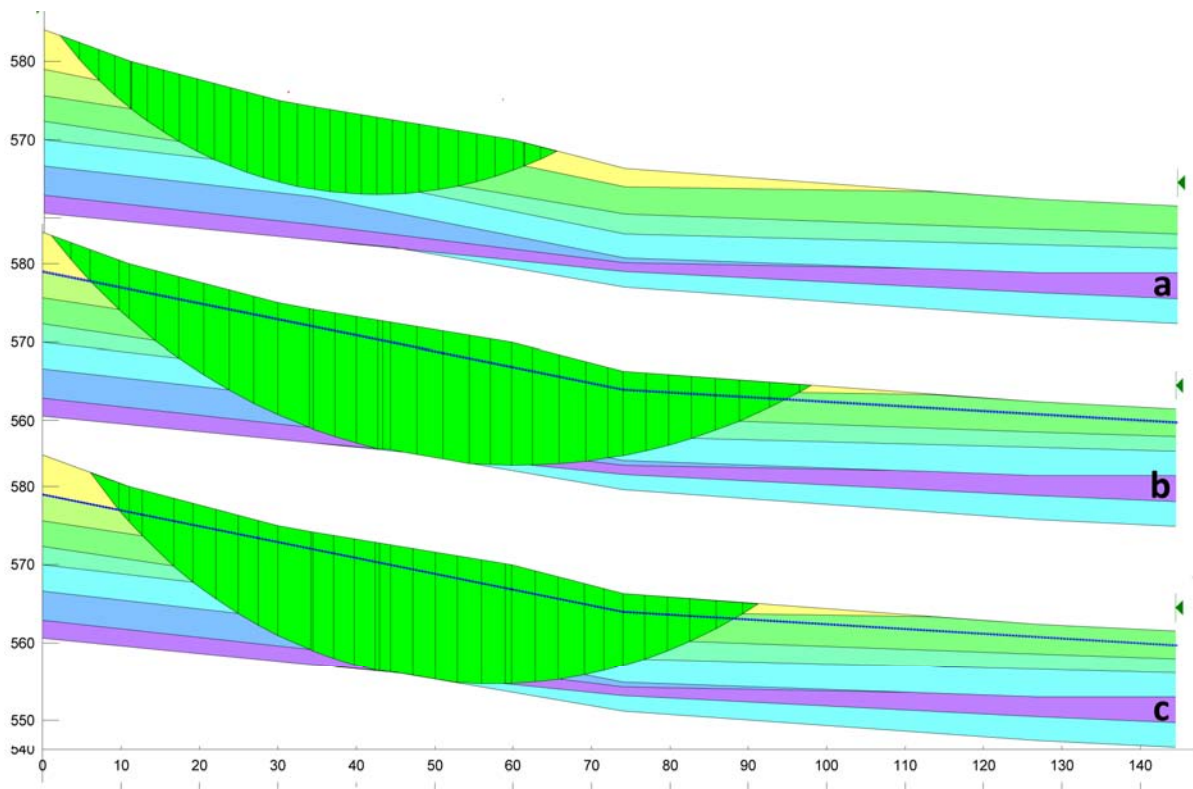
Fig. 7. Different load conditions for Koprivlen-1 landslide: dry (a), high ground water table (b), and High ground water table + earthquake (c). Scale in meters

Slope stability calculations are summarized in Table 2 and Figure 7

Condition of the slope	Slip surface No	Factor of safety, Fs
Dry slope	508	1.854
High ground water table	426	1.272
High ground table + earthquake	438	0.923

In the current slope morphology both with deep groundwater table located under slip surface and with shallow groundwater the factors of safety are significantly above 1. Only in the case of combination between shallow groundwater levels and prognostic earthquake of VIII degree landslide Koprivlen 1 goes into unstable state. Since the landslide Koprivlen-1 is located up the hill, at a considerable distance from the road and do not endanger capital construction, it isn't necessary to conduct special reinforcement activities. Surface-panelled drainage ditches only can be applied to protect slope from penetration of surface waters into the landslide body.

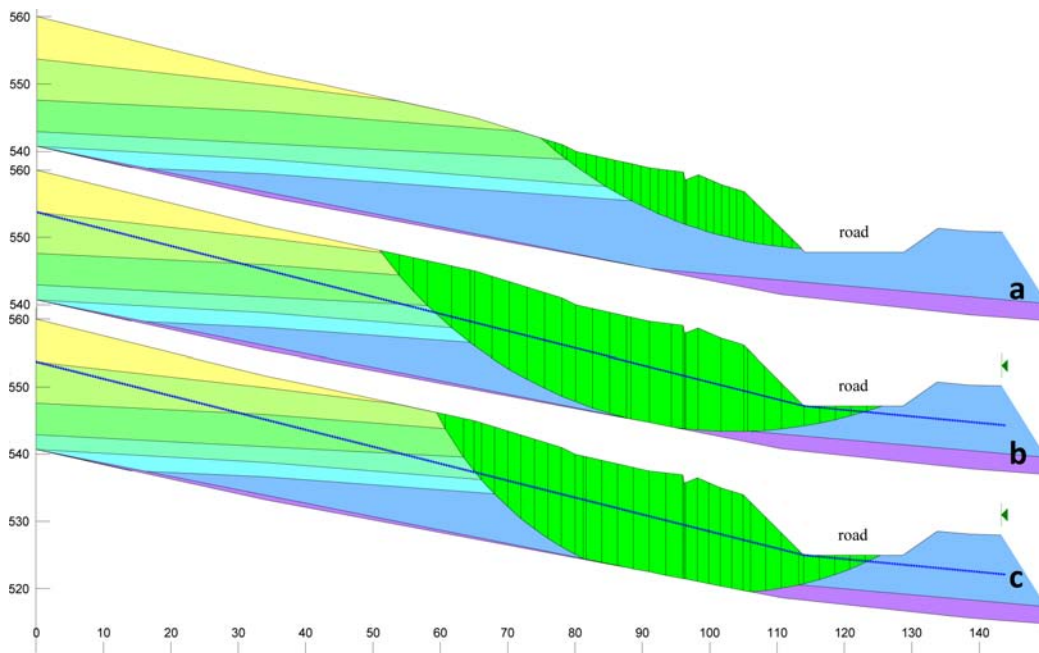
Fig. 8. Different load conditions for Koprivlen-2 landslide: dry (a), high ground water table (b), and High ground water table + earthquake (c). Scale in meters

Slope stability calculations are summarized in Table 3 and Figure 8

Condition of the slope	Slip surface No	Factor of safety, Fs
Dry slope	157	1.278
High ground water table	233	1.044
High ground table + earthquake	252	0.802

In the initial state with deeply located underground water, table slope resistance is higher than the legally required levels. Upon elevation of groundwater the slope passes into a state close to the limit equilibrium. During the prognostic earthquake of VIII degree factor of safety drops significantly and lower part of the landslide passes in a unstable situation which real threatens with strong deformation and breaking the road in this area.
